# **DESIGN & BUILD FOR PROPOSED DRAIN AND EARTHWORK AT ST2 AND ST3 SUNGEI TENGAH ROAD**

## **Trial Pit Report**

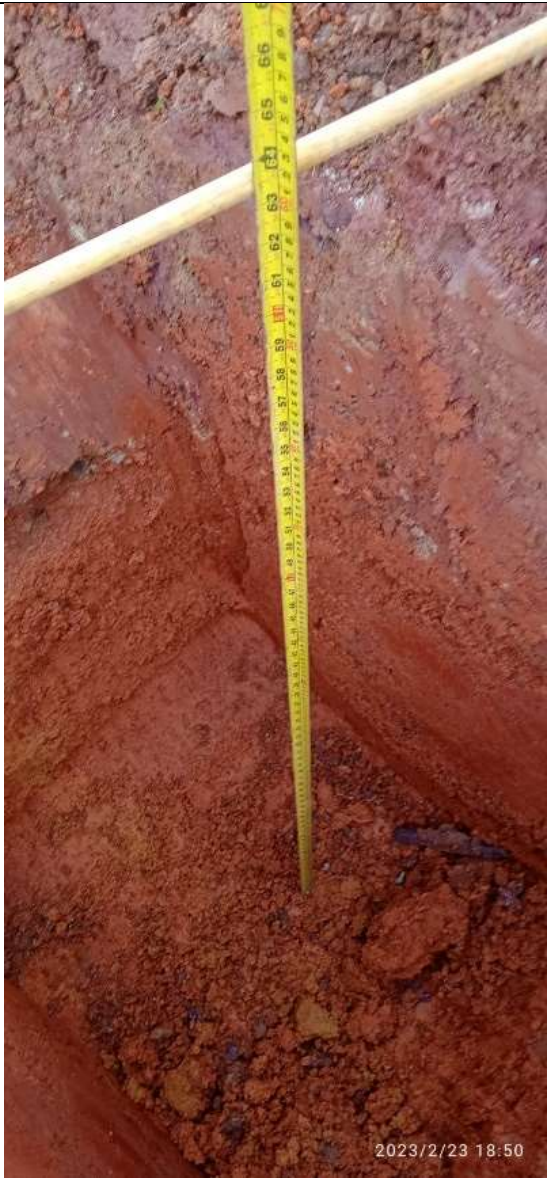
| S/N | Photos | | | | PE's Observation |
|---|---|---|---|---|---|
| Trial Pit No.1 | | | | | No abnormality found within excavated pit. Subsurface water not found within the trial pit. Soil profile and section to refer to Soil Investigation Report. |
| | (1.50) | | 0.00<br>DS 1<br>1.00<br>1.50 | Firm dark yellowish brown and brown fine and medium Sandy SILT. (FILL)<br><br>Ends at 1.5m | |

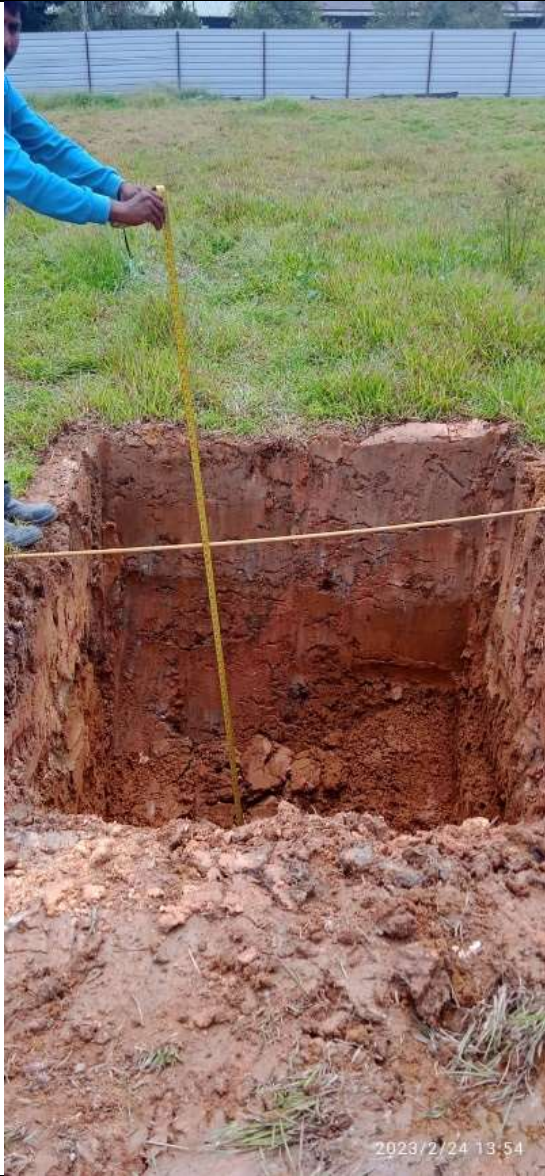
| S/N | Photos | PE's Observation |
|---|---|---|
| Trial Pit No.2 | | <p>No abnormality found within excavated pit. Subsurface water not found within the trial pit. Soil profile and section to refer to Soil Investigation Report.</p> |

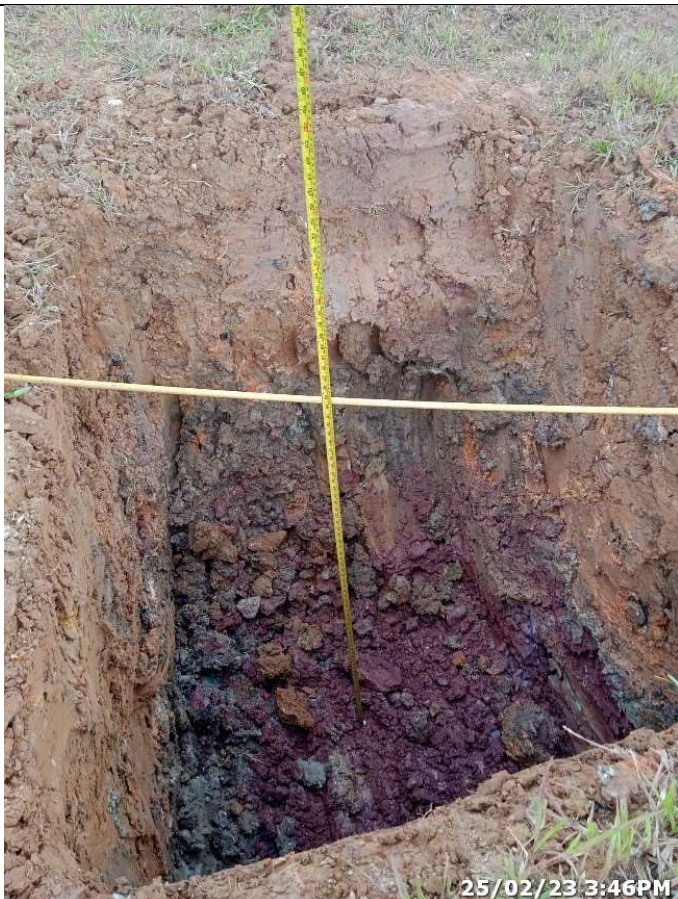
| <p>No abnormality found within excavated pit. Subsurface water not found within the trial pit. Soil profile and section to refer to Soil Investigation Report.</p> | | | | | | | | | | | | | | | | | |
| |

<table><tr> <td>(0.70)</td> <td>—</td> <td>0.00</td> <td rowspan="2">DS 1</td> <td rowspan="2">Soft to firm yellowish grey and yellowish brown fine Sandy Silty CLAY with coarse gravel. (FILL)</td> </tr><tr> <td rowspan="3">(0.80)</td> <td>—</td> <td>1.00</td> <td rowspan="3">DS 2</td> <td rowspan="3">Firm light brownish yellow, light reddish pink and yellowish grey slightly fine Sandy CLAY and some coarse gravel at top of layer. (FILL)</td> </tr></table>

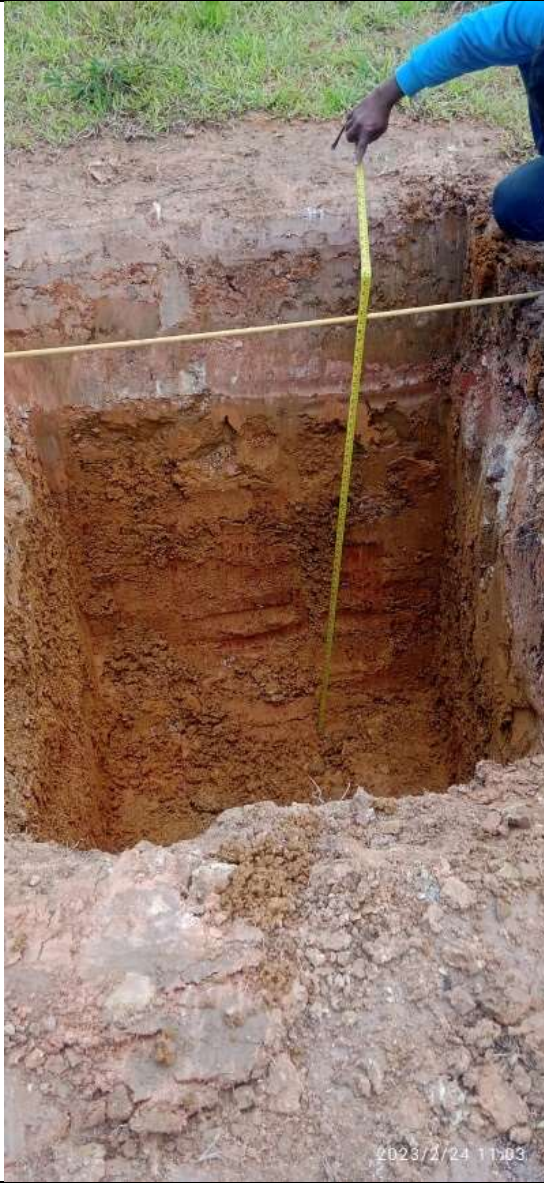
| S/N | Photos | PE's Observation |
|---|---|---|
| Trial Pit No.4 | | <p>No abnormality found within excavated pit. Subsurface water not found within the trial pit. Soil profile and section to refer to Soil Investigation Report.</p> |

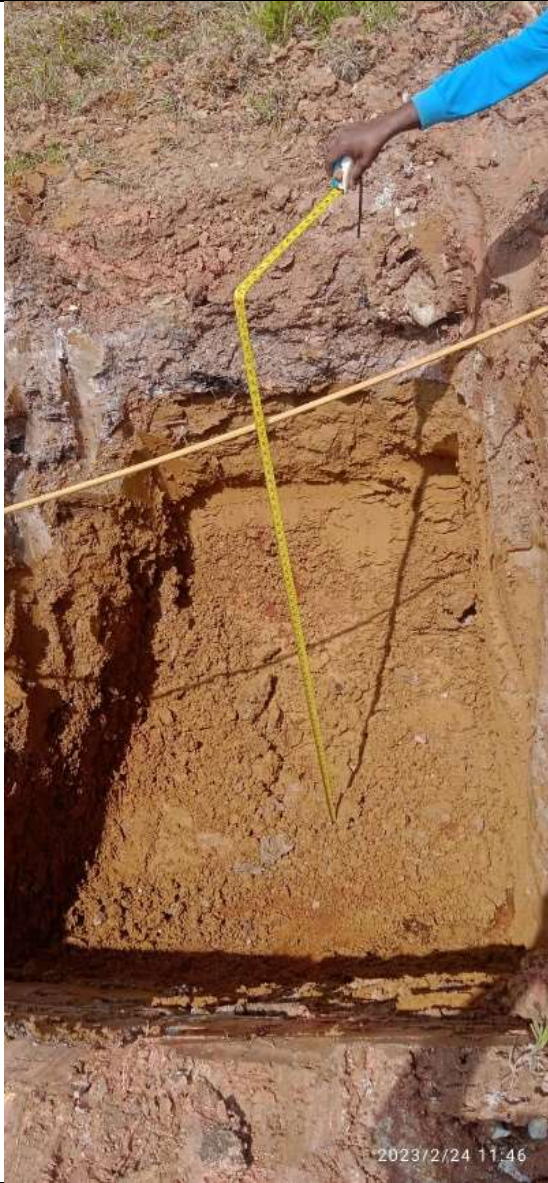
| S/N | Photos | PE's Observation |
|---|---|---|
| Trial Pit No.5 | | <p>No abnormality found within excavated pit. Subsurface water not found within the trial pit. Soil profile and section to refer to Soil Investigation Report.</p> |

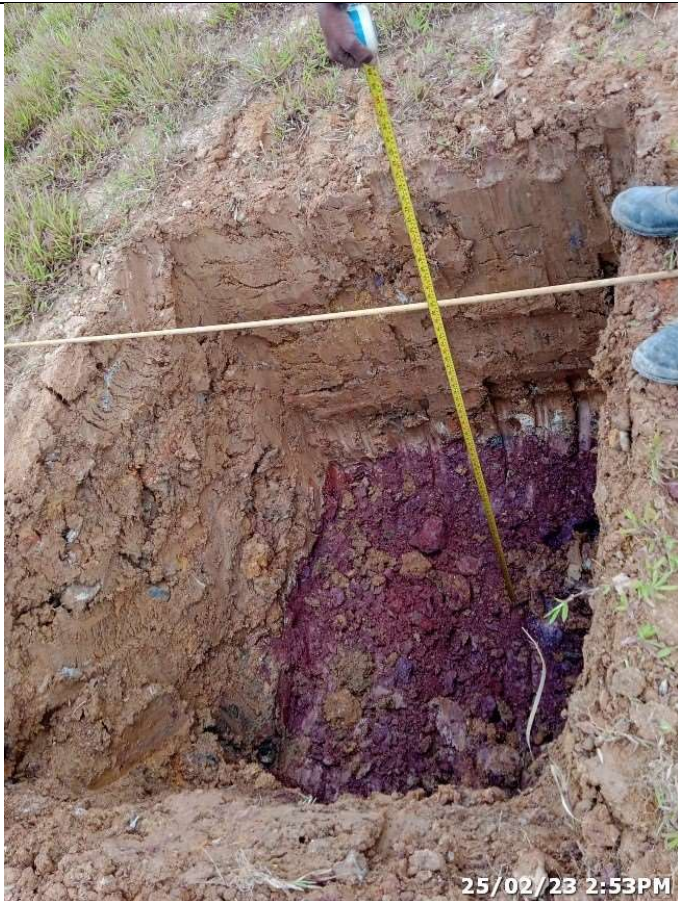
| No abnormality found within excavated pit. Subsurface water not found within the trial pit. Soil profile and section to refer to Soil Investigation Report. | | | | | | | | | | | | | | | | | | | | | | | |
| |

<table><tr><td>(0.70)</td><td>—</td><td>0.00</td><td rowspan="3">DS 1</td><td rowspan="3">Soft to firm yellowish grey and yellowish brown fine Sandy Silty CLAY with coarse gravel. (FILL)</td></tr><tr><td>(0.80)</td><td>—</td><td>1.50</td><td>DS 2</td><td rowspan="3">Firm light brownish yellow, light reddish pink and yellowish grey slightly fine Sandy CLAY and some coarse gravel at top of layer. (FILL)</td></tr></table>

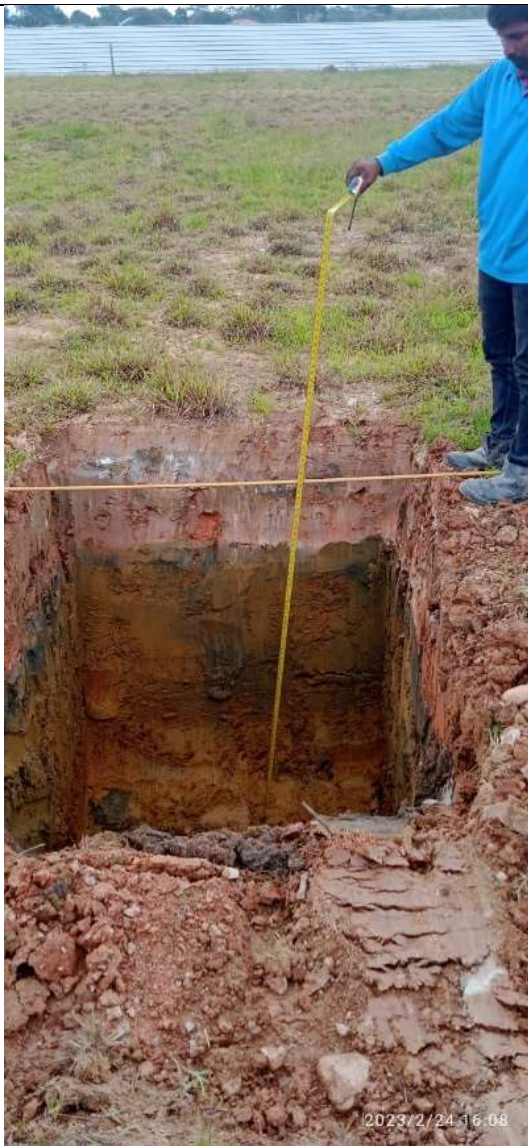
| No abnormality found within excavated pit. Subsurface water not found within the trial pit. Soil profile and section to refer to Soil Investigation Report. | | | | | | | | | | | | | | | |
| |

<table><tr><td>(0.30)</td><td>—</td><td>0.00</td><td rowspan="2">DS 1</td><td rowspan="2">Firm reddish orange and olive grey Sandy Silty CLAY with gravel. (FILL)</td></tr><tr><td>(1.20)</td><td>×</td><td>1.00</td><td>DS 2</td><td rowspan="2">Loose brownish yellow Silty Clayey fine and medium SAND. (FILL)</td></tr></table>

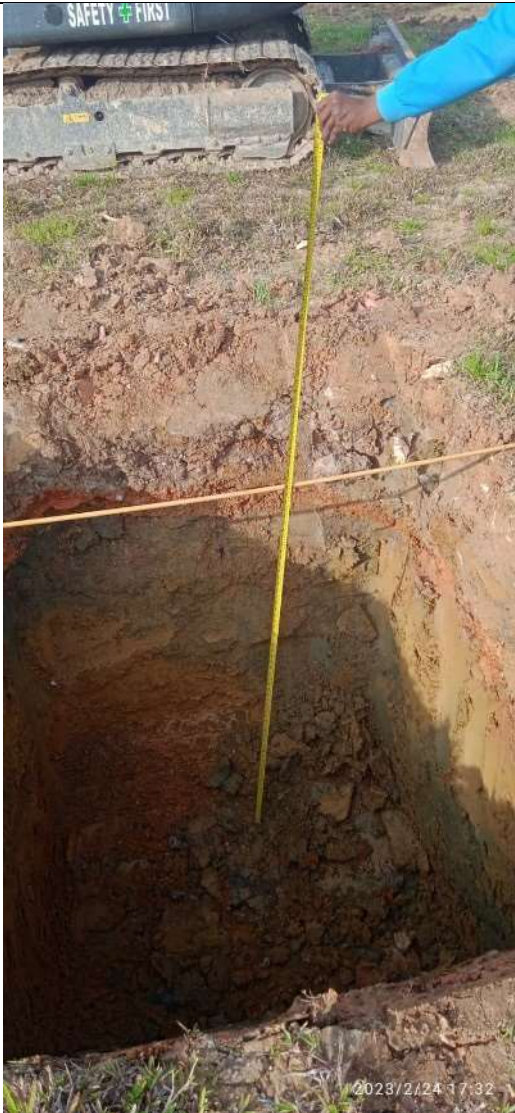
| No abnormality found within excavated pit. Subsurface water not found within the trial pit. Soil profile and section to refer to Soil Investigation Report. | | | | | | | | | | | | | | | | | |
| |

<table><tr><td>(0.30)</td><td>—</td><td>0.00</td><td>DS 1</td><td rowspan="2">Firm reddish orange and olive grey Sandy Silty CLAY with gravel. (FILL)</td></tr><tr><td>1.50</td><td>x</td><td>1.00</td><td></td><td rowspan="2">Loose brownish yellow Silty Clayey fine and medium SAND. (FILL)</td></tr></table>

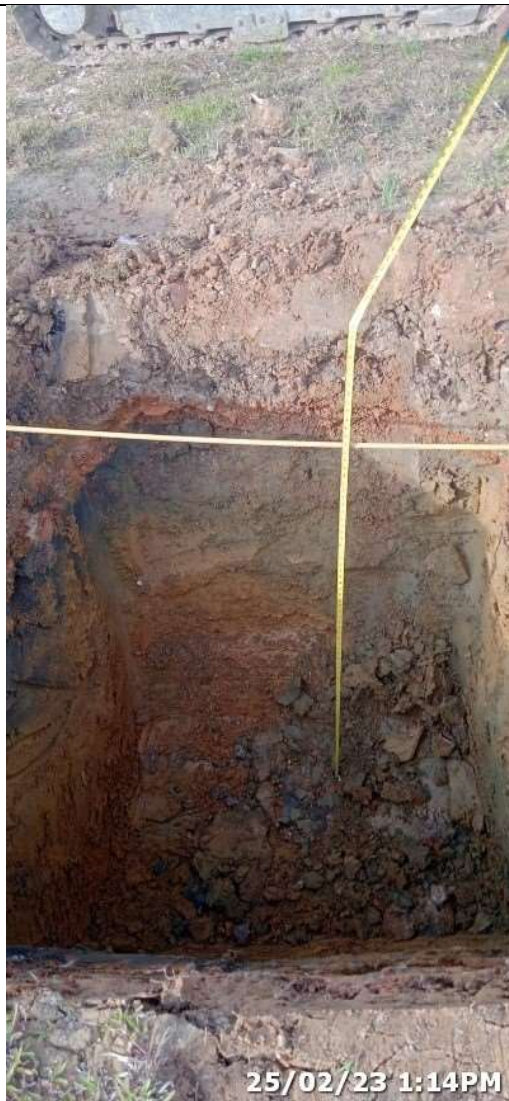
| No abnormality found within excavated pit. Subsurface water not found within the trial pit. Soil profile and section to refer to Soil Investigation Report. | | | | | | | | | | | | | | | | | |
| |

<table><tr><td>(0.30)</td><td>—</td><td>0.00</td><td>DS 1</td><td rowspan="2">Firm reddish orange and olive grey Sandy Silty CLAY with gravel. (FILL)</td></tr><tr><td>(1.20)</td><td>x</td><td>1.00</td><td></td><td rowspan="2">Loose brownish yellow Silty Clayey fine and medium SAND. (FILL)</td></tr></table>

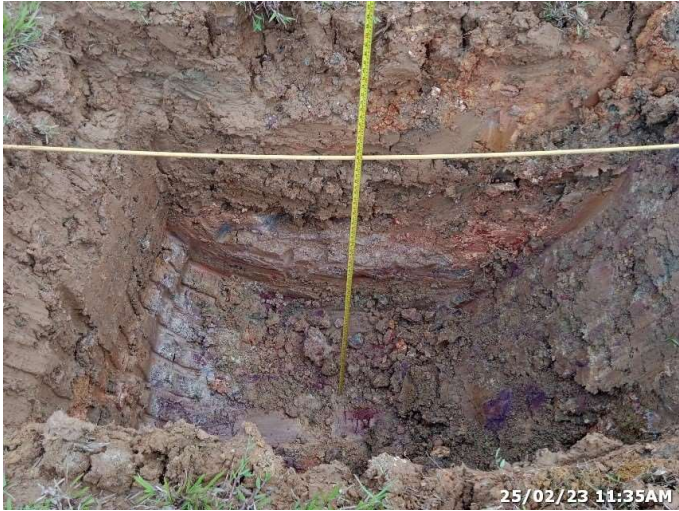
| S/N | Photos | PE's Observation |
|---|---|---|
| Trial Pit No.10 | | <p>No abnormality found within excavated pit. Subsurface water not found within the trial pit. Soil profile and section to refer to Soil Investigation Report.</p> |

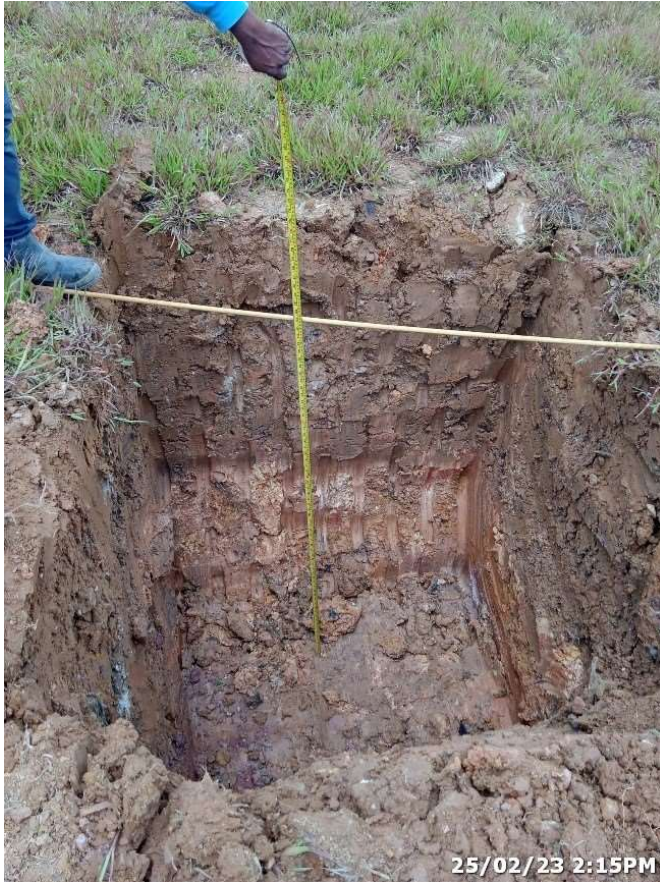
| S/N | Photos | PE's Observation |
|---|---|---|
| Trial Pit No.11 | | <p>No abnormality found within excavated pit. Subsurface water not found within the trial pit. Soil profile and section to refer to Soil Investigation Report.</p> |
| | <div style="display: flex; align-items: center;"> <div style="border: 1px solid black; padding: 5px; margin-right: 10px;"> <div style="display: flex; align-items: center;"> <div style="width: 40px; text-align: center;">(1.50)</div> <div style="width: 40px; text-align: center;">1.50</div> <div style="width: 40px; text-align: center;"> <div style="border-left: 1px solid black; border-right: 1px solid black; height: 100px; position: relative;"> <div style="position: absolute; top: 0; left: 0; right: 0; bottom: 0; border-left: 1px solid black; border-right: 1px solid black;"></div> </div> </div> </div> <div style="margin-left: 10px;"> <div style="text-align: right;">0.00</div> <div style="text-align: center;">DS 1</div> <div style="text-align: left;">1.00</div> <div style="text-align: left;">1.50</div> </div> </div> <div style="border: 1px solid black; padding: 5px; margin-left: 10px;"> <p>Soft to firm reddish orange and brown fine Sandy Silty CLAY with some gravel. (FILL)</p> </div> </div> | |

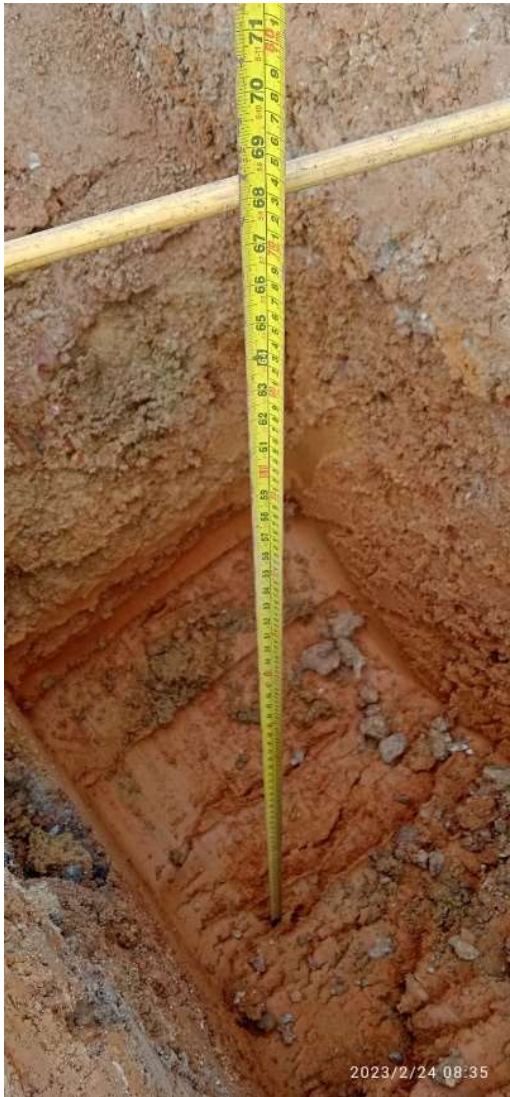
| S/N | Photos | PE's Observation |
|---|---|---|
| Trial Pit No.12 | | No abnormality found within excavated pit. Subsurface water not found within the trial pit. Soil profile and section to refer to Soil Investigation Report. |
| | | Firm dark yellowish brown and brown fine and medium Sandy SILT. (FILL) |

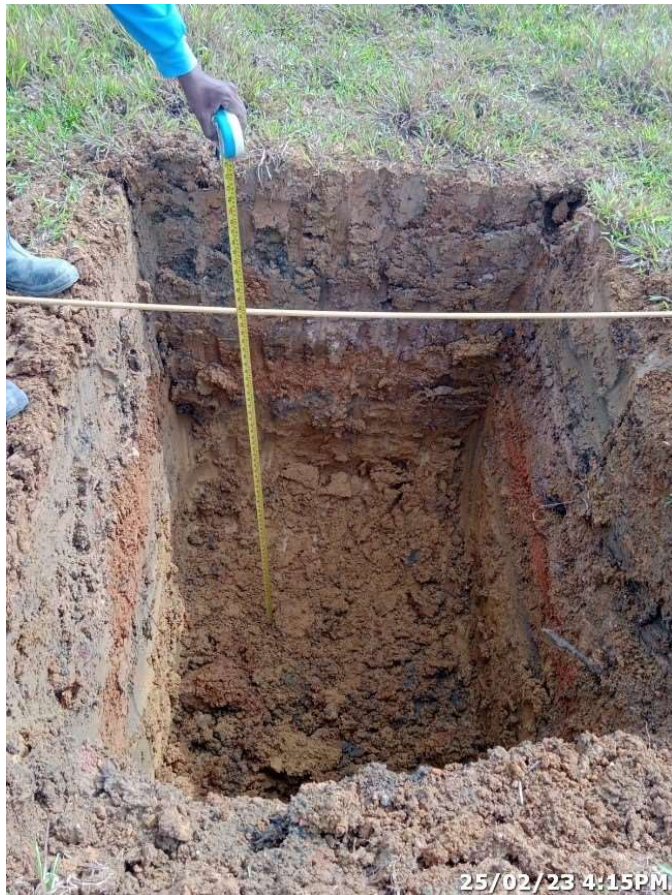
| <p>No abnormality found within excavated pit. Subsurface water not found within the trial pit. Soil profile and section to refer to Soil Investigation Report.</p> | | | |
| | <table> <tr> <td>(1.50)</td> <td> <ul style="list-style-type: none"> <li>• ×</li> <li>• ×</li> <li>• ×</li> <li>• ×</li> <li>• ×</li> <li>• ×</li> <li>• ×</li> <li>• ×</li> <li>• ×</li> <li>• ×</li> </ul> </td> <td>

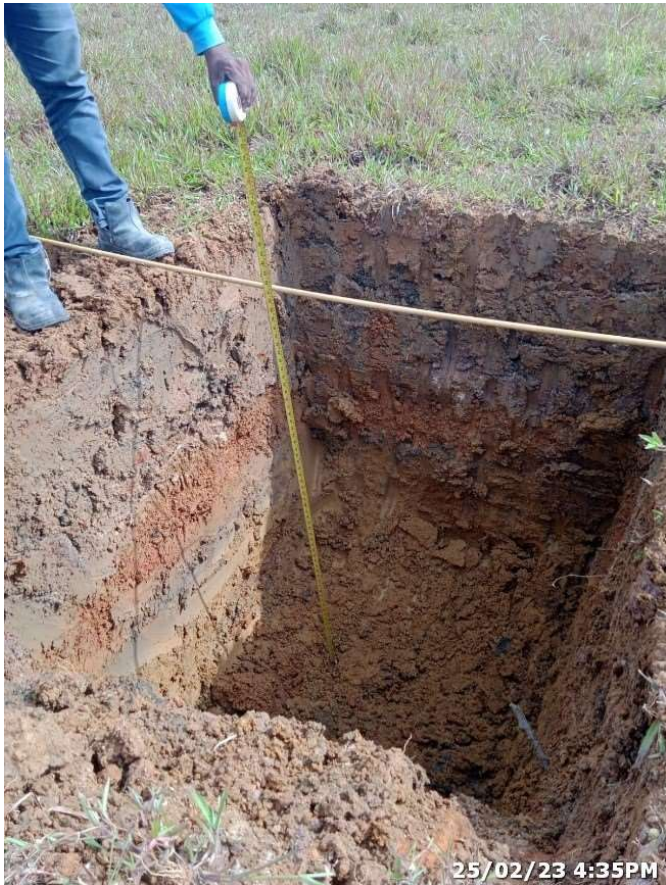
| No abnormality found within excavated pit. Subsurface water not found within the trial pit. Soil profile and section to refer to Soil Investigation Report. | | | |
| | <table><tr><td>(1.50)</td><td><div><div>• ×</div><div>• ×</div><div>• ×</div><div>• ×</div><div>• ×</div><div>• ×</div><div>• ×</div><div>• ×</div><div>• ×</div><div>• ×</div></div></td><td>

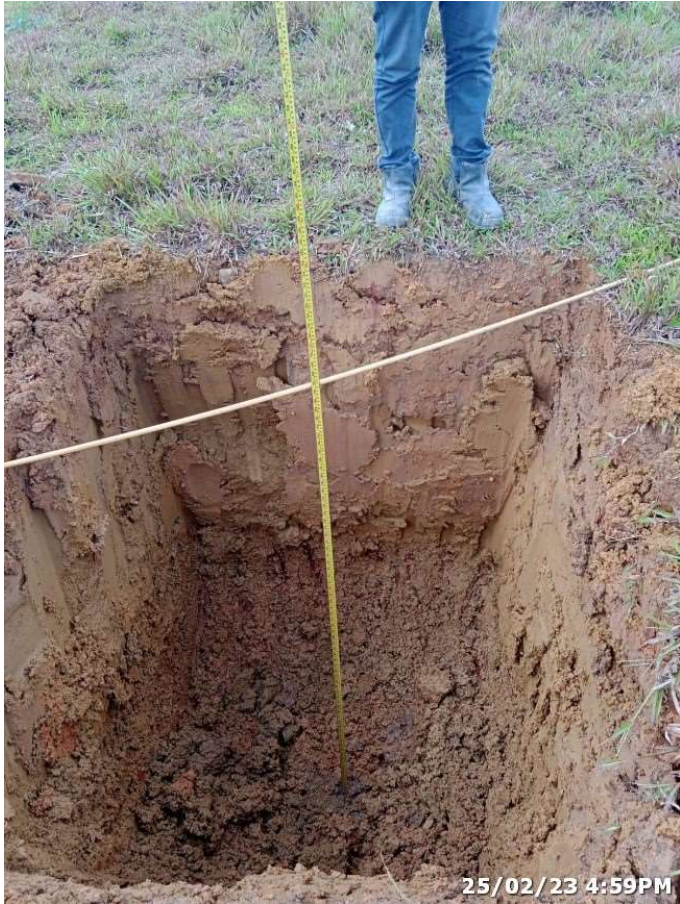
| S/N | Photos | PE's Observation |
|---|---|---|
| Trial Pit No.16 | | <p>No abnormality found within excavated pit. Subsurface water not found within the trial pit. Soil profile and section to refer to Soil Investigation Report.</p> |

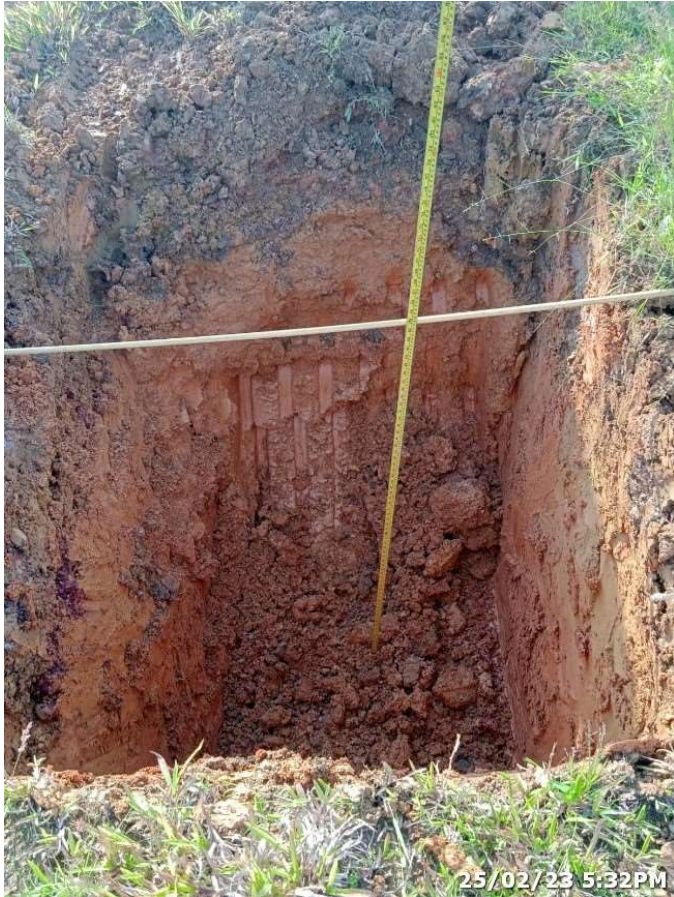
| S/N | Photos | PE's Observation |
|---|---|---|
| Trial Pit No.17 | | <p>No abnormality found within excavated pit. Subsurface water not found within the trial pit. Soil profile and section to refer to Soil Investigation Report.</p> |

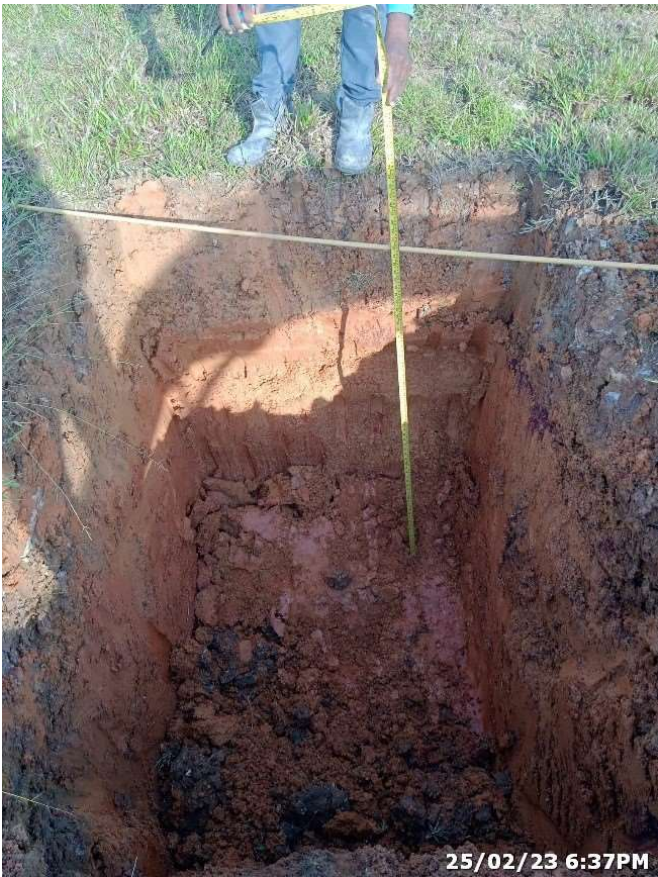
| S/N | Photos | PE's Observation |
|---|---|---|
| Trial Pit No.18 | | <p>No abnormality found within excavated pit. Subsurface water not found within the trial pit. Soil profile and section to refer to Soil Investigation Report.</p> |

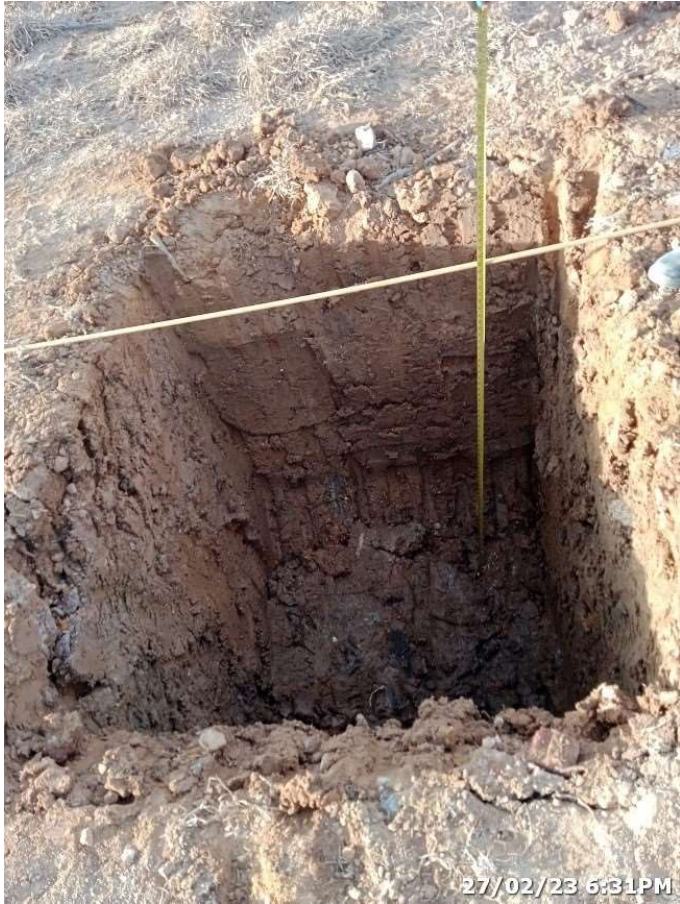
| S/N | Photos | PE's Observation |
|---|---|---|
| Trial Pit No.19 | | <p>No abnormality found within excavated pit. Subsurface water not found within the trial pit. Soil profile and section to refer to Soil Investigation Report.</p> |

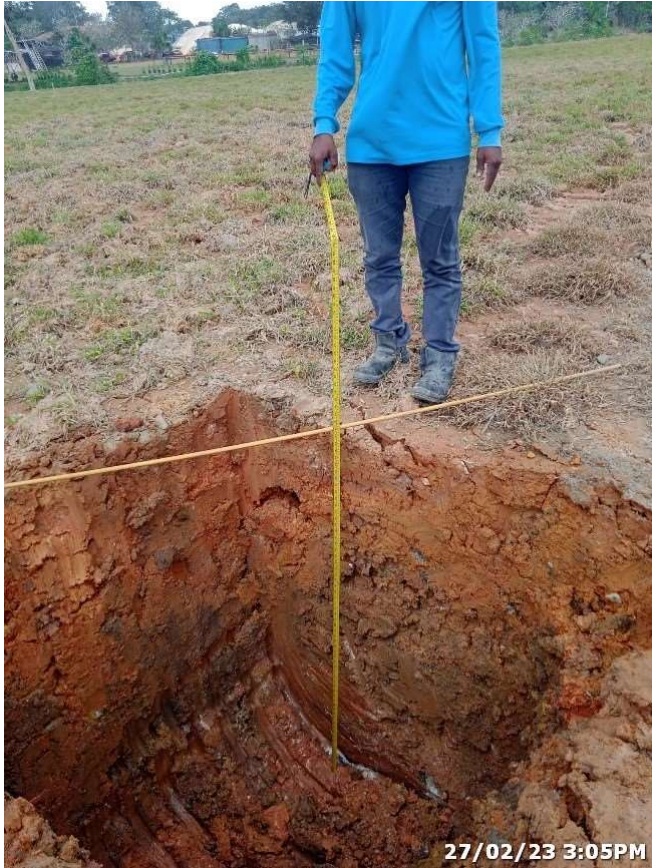
| S/N | Photos | PE's Observation |
|---|---|---|
| Trial Pit No.20 | | <p>No abnormality found within excavated pit. Subsurface water not found within the trial pit. Soil profile and section to refer to Soil Investigation Report.</p> |

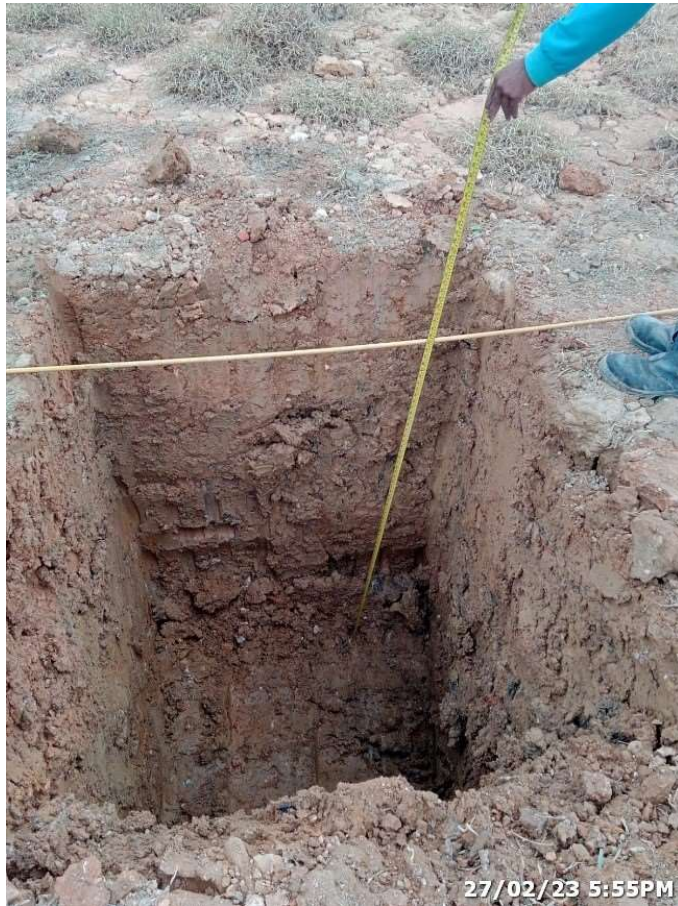
| S/N | Photos | PE's Observation |
|---|---|---|
| Trial Pit No.21 | | <p>No abnormality found within excavated pit. Subsurface water not found within the trial pit. Soil profile and section to refer to Soil Investigation Report.</p> |

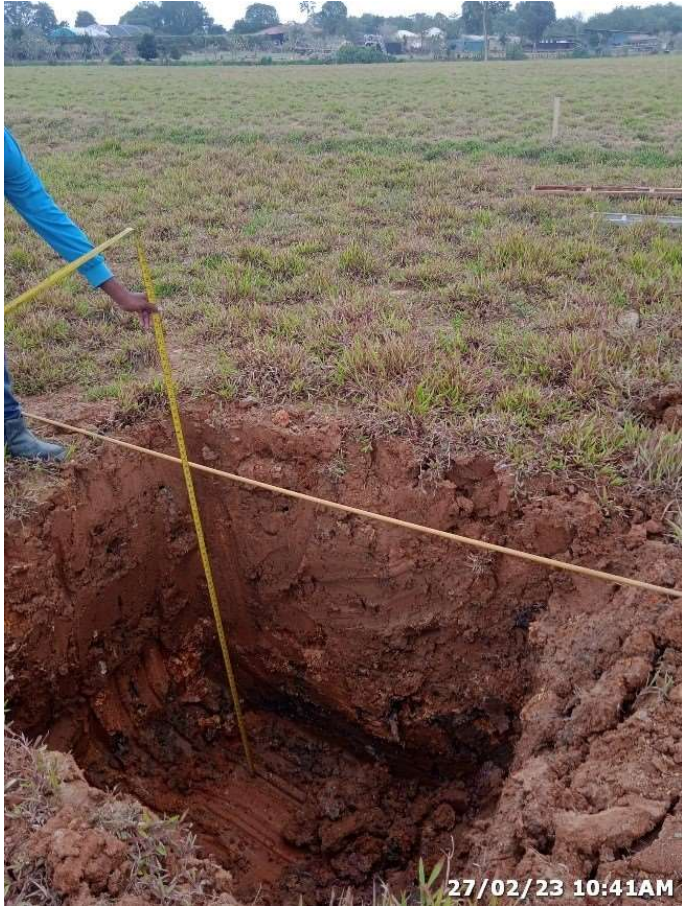
| S/N | Photos | PE's Observation |
|---|---|---|
| Trial Pit No.22 | | <p>No abnormality found within excavated pit. Subsurface water not found within the trial pit. Soil profile and section to refer to Soil Investigation Report.</p> |

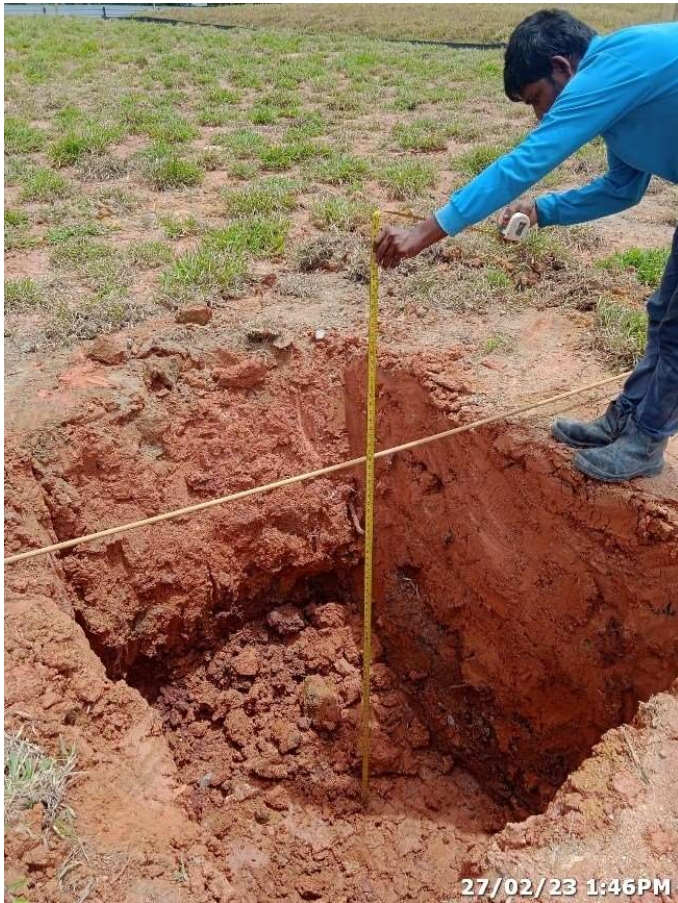
| <p>No abnormality found within excavated pit. Subsurface water not found within the trial pit. Soil profile and section to refer to Soil Investigation Report.</p> | | | |
| | <table> <tr> <td>(1.50)</td> <td> <ul style="list-style-type: none"> <li>• ×</li> <li>• ×</li> <li>• ×</li> <li>• ×</li> <li>• ×</li> <li>• ×</li> <li>• ×</li> <li>• ×</li> <li>• ×</li> <li>• ×</li> </ul> </td> <td>

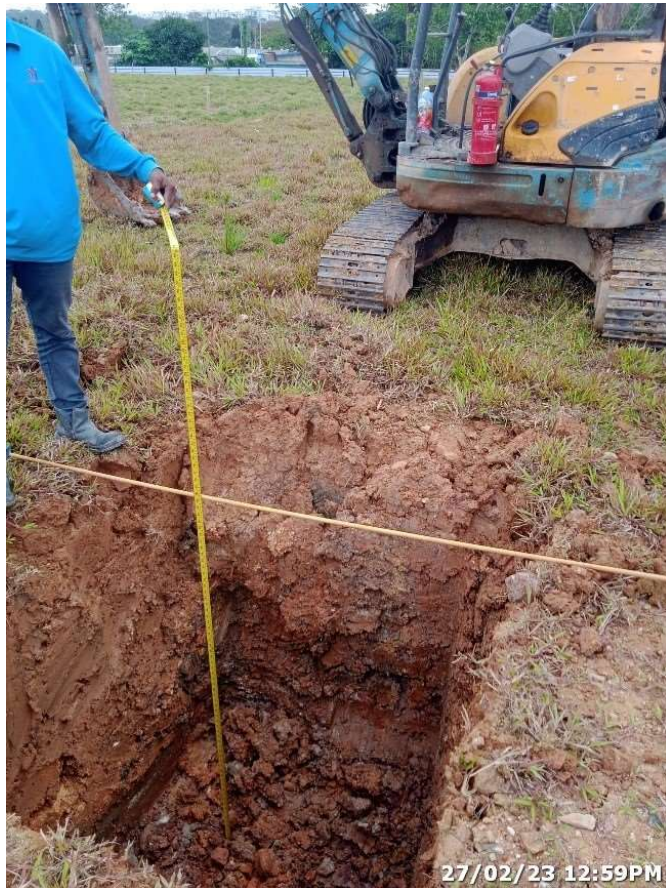
| <p>No abnormality found within excavated pit. Subsurface water not found within the trial pit. Soil profile and section to refer to Soil Investigation Report.</p> | | | | | | | | | | | | | | | | | | | | | | | | | | | | | | | |
| |

<table><tr> <td rowspan="10">(1.50)</td> <td>×</td> <td rowspan="10">  </td> <td>0.00</td> <td rowspan="10"> <p>Firm reddish orange and brownish yellow fine and medium Sandy SILT. (FILL)</p> </td> </tr></table>

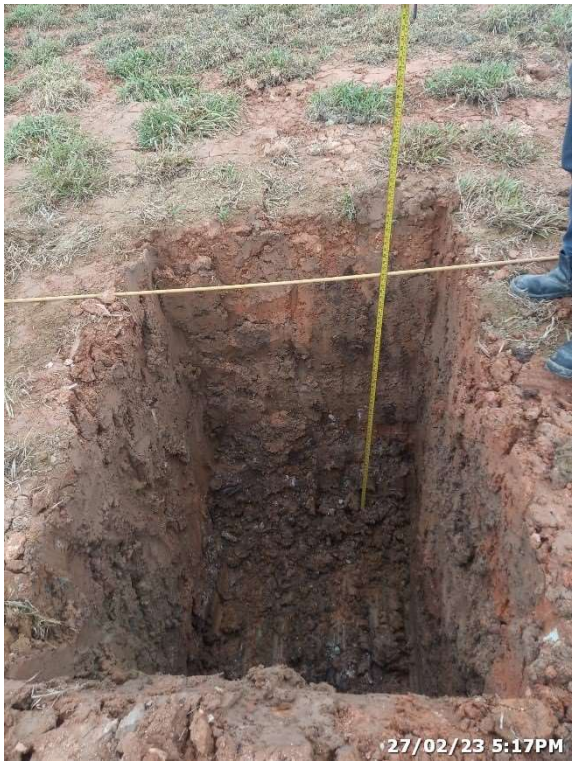
| S/N | Photos | PE's Observation |
|---|---|---|
| Trial Pit No.25 | | <p>No abnormality found within excavated pit. Subsurface water not found within the trial pit. Soil profile and section to refer to Soil Investigation Report.</p> |

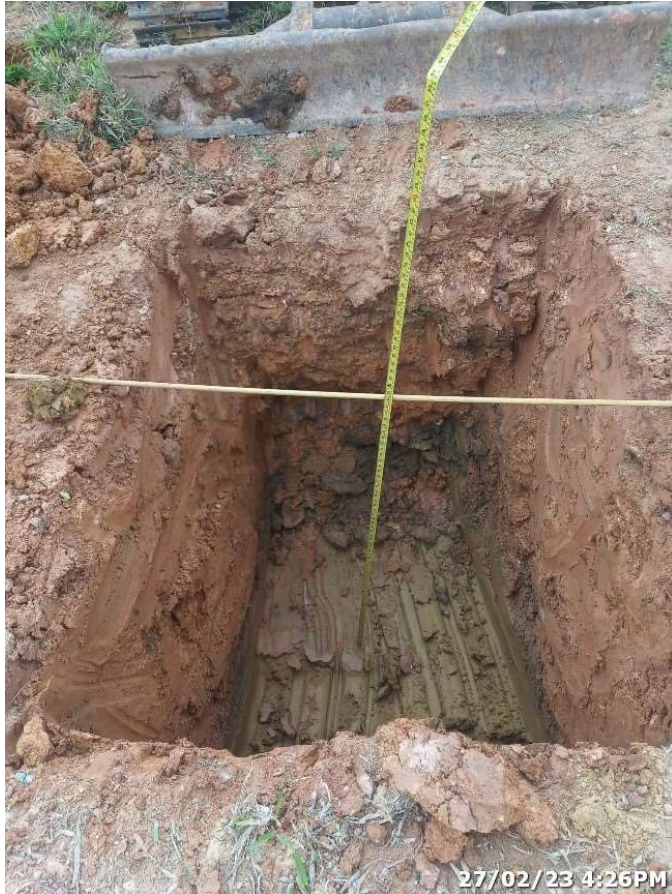
| S/N | Photos | PE's Observation |
|---|---|---|
| Trial Pit No.26 | | <p>No abnormality found within excavated pit. Subsurface water not found within the trial pit. Soil profile and section to refer to Soil Investigation Report.</p> |

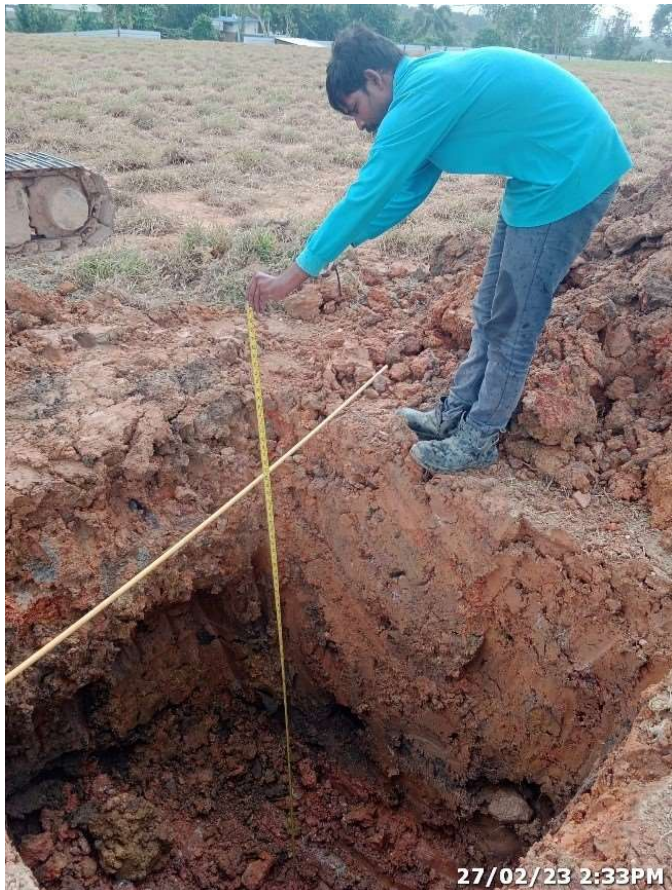
| <p>No abnormality found within excavated pit. Subsurface water not found within the trial pit. Soil profile and section to refer to Soil Investigation Report.</p> | | | | | | | | | | | | | | | | | | | |
| |

<table><tr> <td rowspan="10">(1.50)</td> <td>×</td> <td rowspan="10">  </td> <td>0.00</td> <td rowspan="10"> <p>Firm reddish orange and brownish yellow fine and medium Sandy SILT. (FILL)</p> </td> </tr></table>

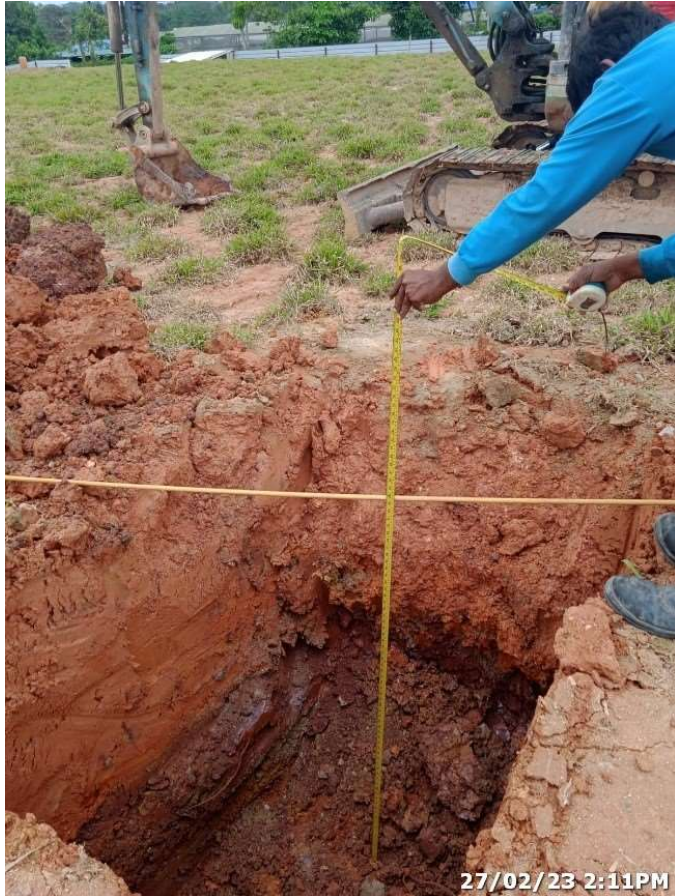
| S/N | Photos | PE's Observation |
|---|---|---|
| Trial Pit No.28 | | <p>No abnormality found within excavated pit. Subsurface water not found within the trial pit. Soil profile and section to refer to Soil Investigation Report.</p> |

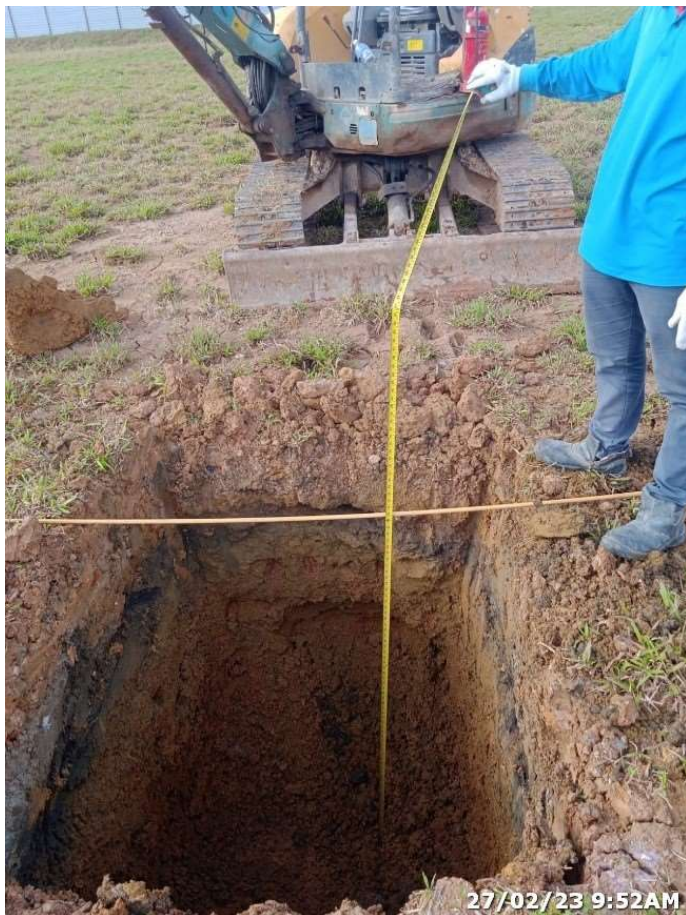
| <p>No abnormality found within excavated pit. Subsurface water not found within the trial pit. Soil profile and section to refer to Soil Investigation Report.</p> | | | |
| | <table> <tr> <td>(1.50)</td> <td> <ul style="list-style-type: none"> <li>• ×</li> <li>• ×</li> <li>• ×</li> <li>• ×</li> <li>• ×</li> <li>• ×</li> <li>• ×</li> <li>• ×</li> </ul> </td> <td>

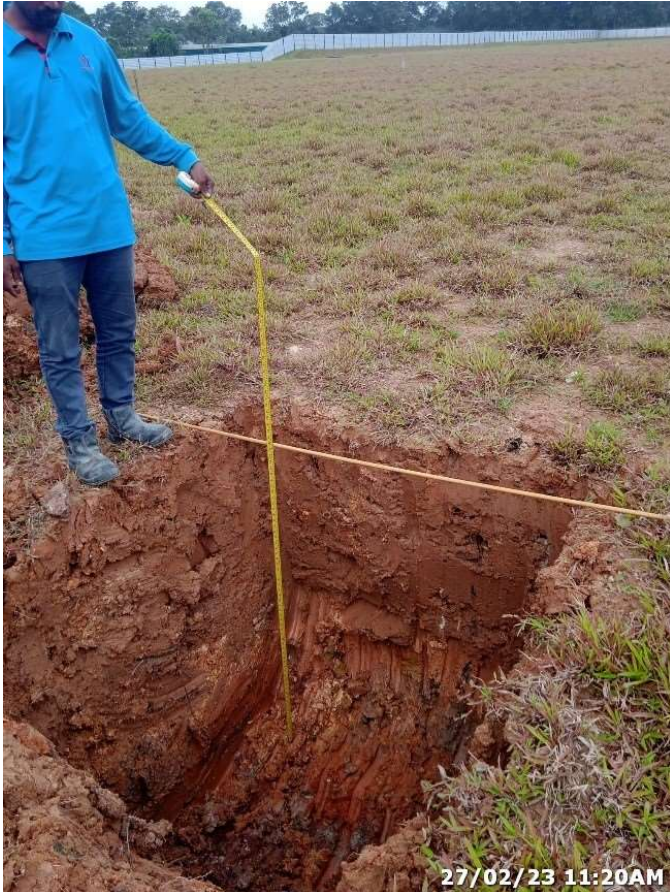
| S/N | Photos | PE's Observation |
|---|---|---|
| Trial Pit No.30 | | <p>No abnormality found within excavated pit. Subsurface water not found within the trial pit. Soil profile and section to refer to Soil Investigation Report.</p> |

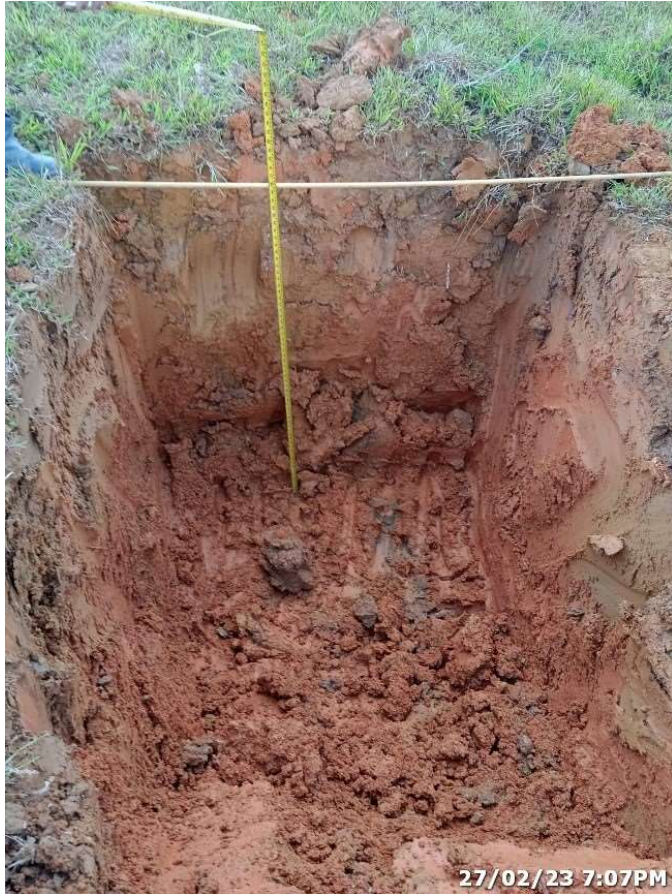
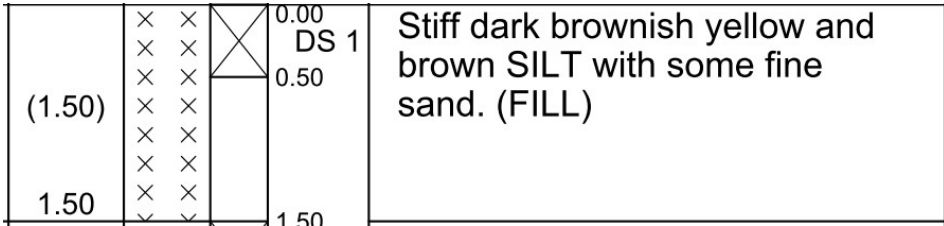
| S/N | Photos | PE's Observation |
|---|---|---|
| Trial Pit No.31 | | <p>No abnormality found within excavated pit. Subsurface water not found within the trial pit. Soil profile and section to refer to Soil Investigation Report.</p> |

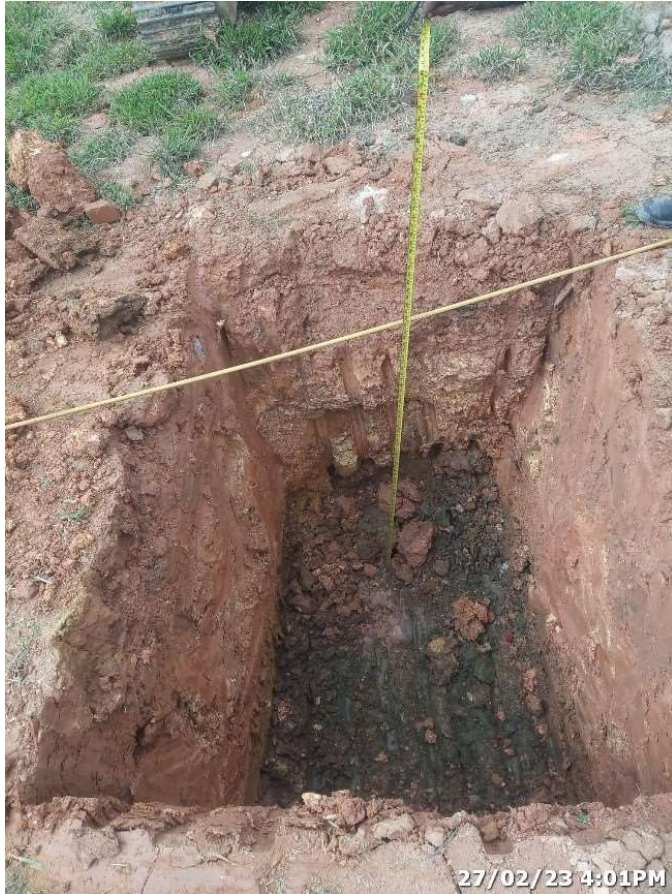
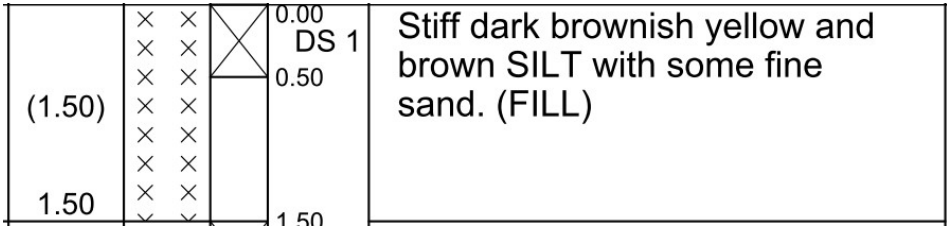
| S/N | Photos | PE's Observation |
|---|---|---|
| Trial Pit No.32 | | <p>No abnormality found within excavated pit. Subsurface water not found within the trial pit. Soil profile and section to refer to Soil Investigation Report.</p> |

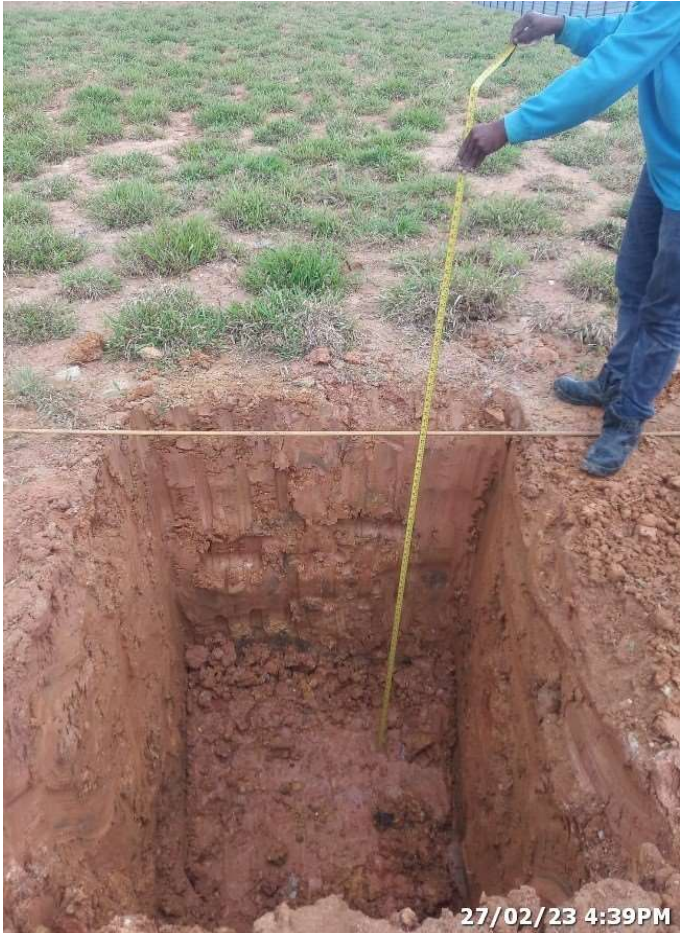
| No abnormality found within excavated pit. Subsurface water not found within the trial pit. Soil profile and section to refer to Soil Investigation Report. | | | | | | | | | | | | | | | | | | | | | | | | | | | | | | | | | | | | | | | | | | | | | |
| |

<table><tr><td></td><td>×</td><td>×</td><td>0.00</td><td rowspan="2">DS 1</td><td rowspan="2">Stiff dark brownish yellow and brown SILT with some fine sand. (FILL)</td></tr></table>
