# **DESIGN & BUILD FOR PROPOSED DRAIN AND EARTHWORK AT ST2 AND ST3 SUNGEI TENGAH ROAD**

## **Trial Pit Report**

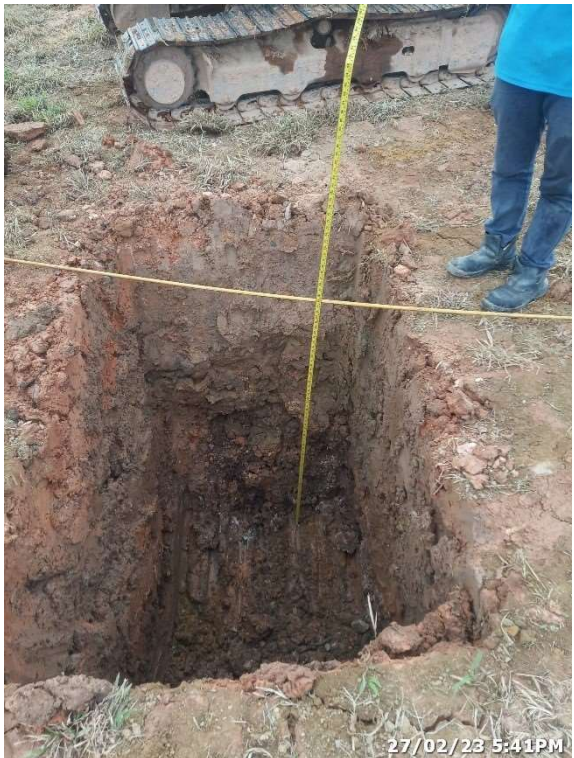
| S/N | Photos | PE's Observation |
|---|---|---|
| Trial Pit No.34 | | <p>No abnormality found within excavated pit. Subsurface water not found within the trial pit. Soil profile and section to refer to Soil Investigation Report.</p> |
