# **SUB-SURFACE CONDITION ASSESSMENT OF LAND PARCEL LCK 114A AT LIM CHU KANG**

## **ASSESSMENT REPORT**

**Date:** 05<sup>th</sup> March 2020

SLA/058/SLA/LKC114A/-\_PE1-29-LAMD-2018-SAP

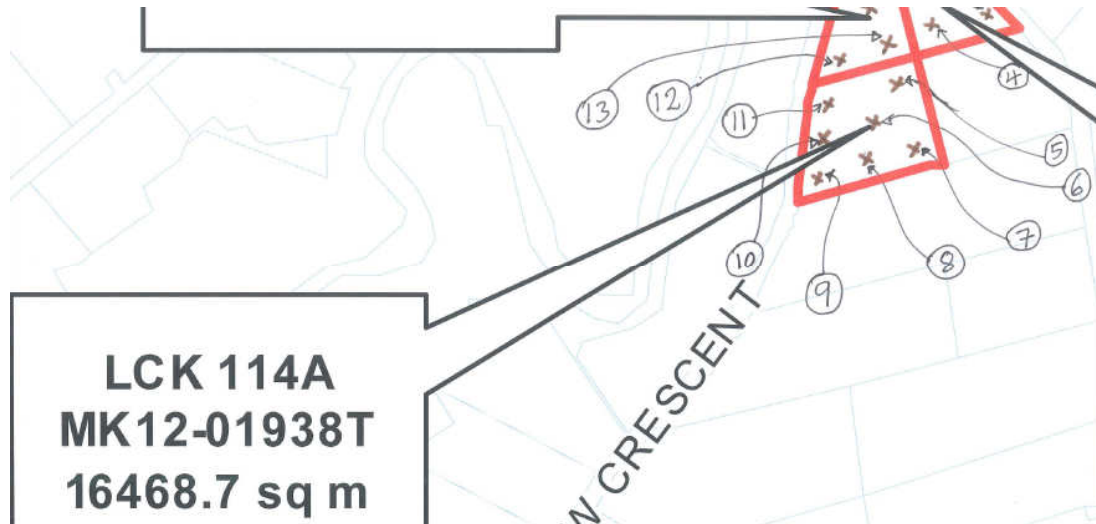
#### **Trial pit No. 5:**

Original State : Topped with natural grass and crops

Type of Soil : Slightly hard whitish sandy SILT to reddish firm sandy SILT at 1.5m depth

Other Material : Not found

Water Table : Not found
